# SEISMIC EVALUATION & RETROFIT ASSESSMENT OF JLNM1 HOSPITAL, RAINAWARI SRINAGAR

Javaid Ahmad<sup>1</sup>, Dr. A. R. Dar<sup>2</sup>

## Abstract

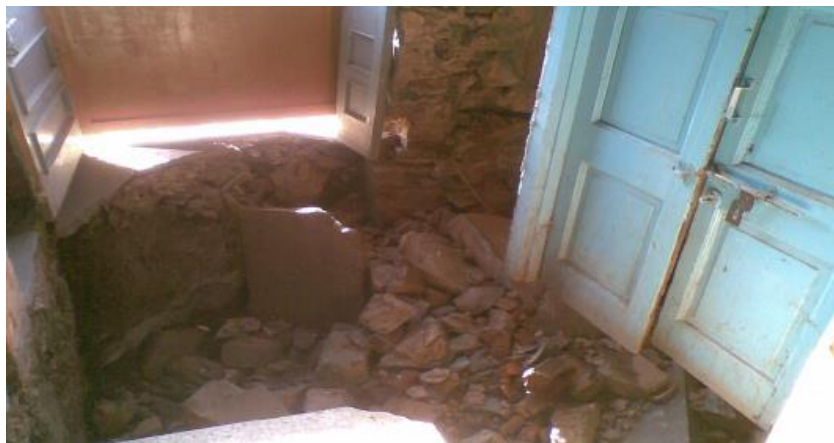
**Fig. 1:** Sinking of floor

Rainawari was previously known as “Kralyar” meaning “Potters Town” because the main occupation was the people there was making earthen utensils and other household things. For this purpose they used to dig caves/cavities for getting the soil. Thus various caves and cavities are still expected to be there in the ground which when subjected to the loads from above may lead to subsidence of the ground surface which eventually creates various problems in the structure. Since JLMN Hospital is located in the same region, the cause of subsidence at the entrance is probably due to the same reason.

- I. **Seismic belts:** Provide seismic belts at lintel roof level to provide stability to the building against the lateral forces.
- II. **Grouting:** Fill the cracks with cement grout or epoxy resin (as applicable) to close the prevailing crack therein. [Clause 7.3.1; 5.3; 6.3]
- III. **Concrete Jacketing:** Apply the concrete jacket to the wall in Fig. 3 after filling the crack with cement grout. [Clause 7.8]
- IV. **Foundation Strengthening:**  
**Underpinning:** It involves the removal of unsuitable soil underneath, coupled with replacement using concrete, soil cement, suitable soil, or other material. Underpinning has to be staged in small increments to prevent endangering the stability of the structure. This technique will enlarge the existing footing or extend it to a more competent soil stratum.

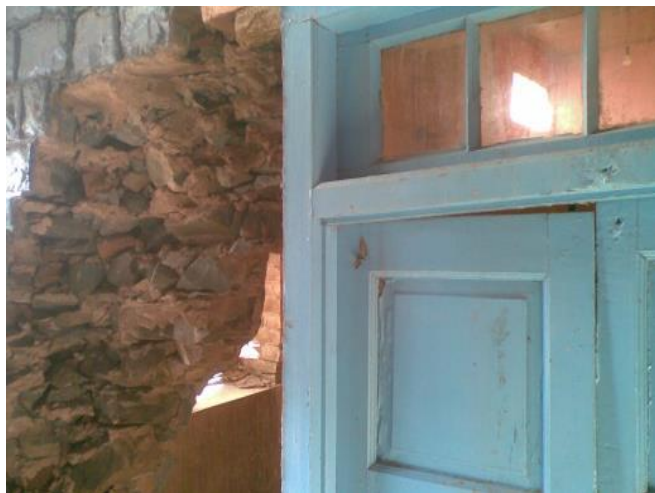
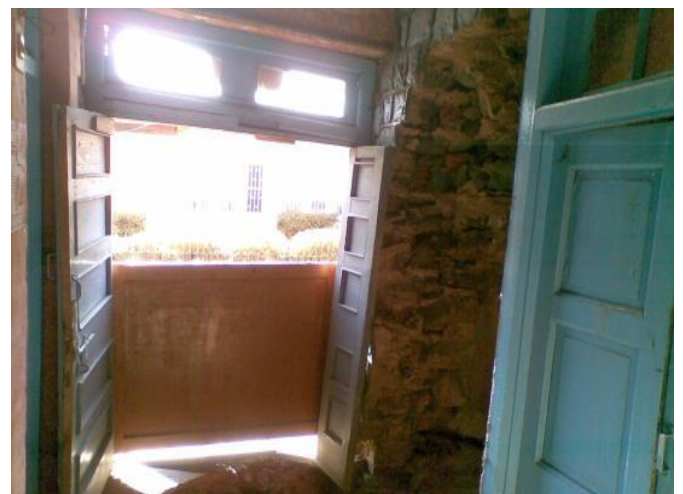
**Fig. 2:** Damage in the walls

Due the inadequate maintenance and fitting of the bathrooms, there has been leakage of water which has percolated into the foundation. This in turn led to the subsequent subsidence just adjacent to the sides of the bathrooms.

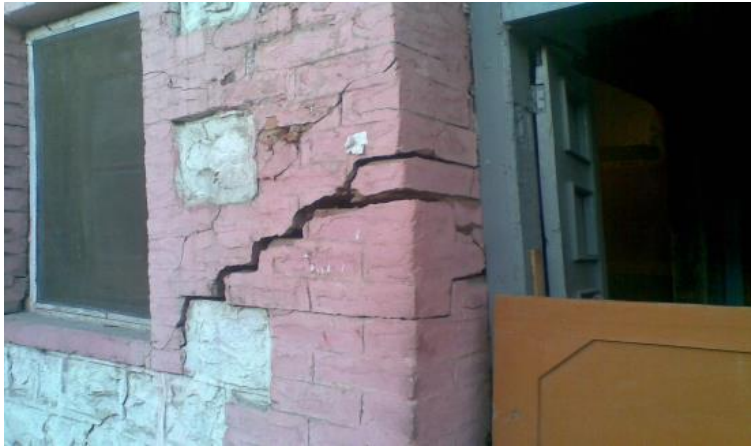
**Fig. 3:** Large crack in the wall

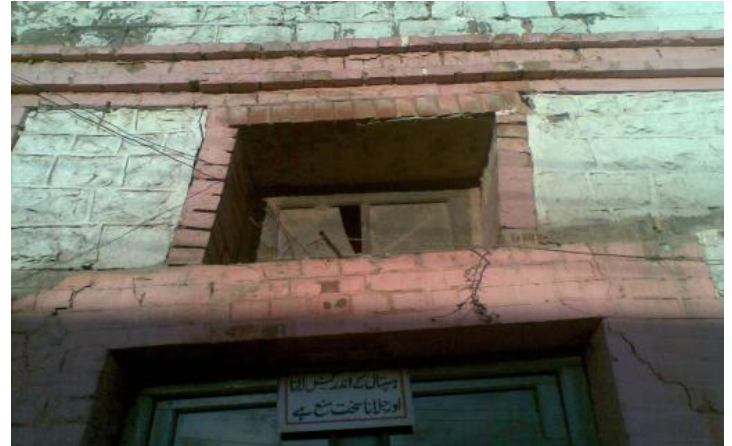
**Fig. 4:** Sway of front wall

The existing building is constructed using stone masonry. As such the building doesn't have any bands (lintel band, sill band, gable band, plinth band) which are necessary to be provided as per the guidelines of the seismic codes of design for masonry structures. This can also be attributed for the sway of the building.
